# NATIONAL TRANSPORTATION SAFETY BOARD

## RAILROAD ACCIDENT REPORT

DERAILMENT OF  
SOUTHERN PACIFIC TRANSPORTATION COMPANY  
FREIGHT TRAIN ON MAY 12, 1989  
AND SUBSEQUENT RUPTURE OF  
CALNEV PETROLEUM PIPELINE ON MAY 25, 1989  
SAN BERNARDINO, CALIFORNIA

| <b>1. Report No.</b><br>NTSB/RAR-90/02 | <b>2. Government Accession No.</b><br>PB90-916302 | <b>3. Recipient's Catalog No.</b> | |

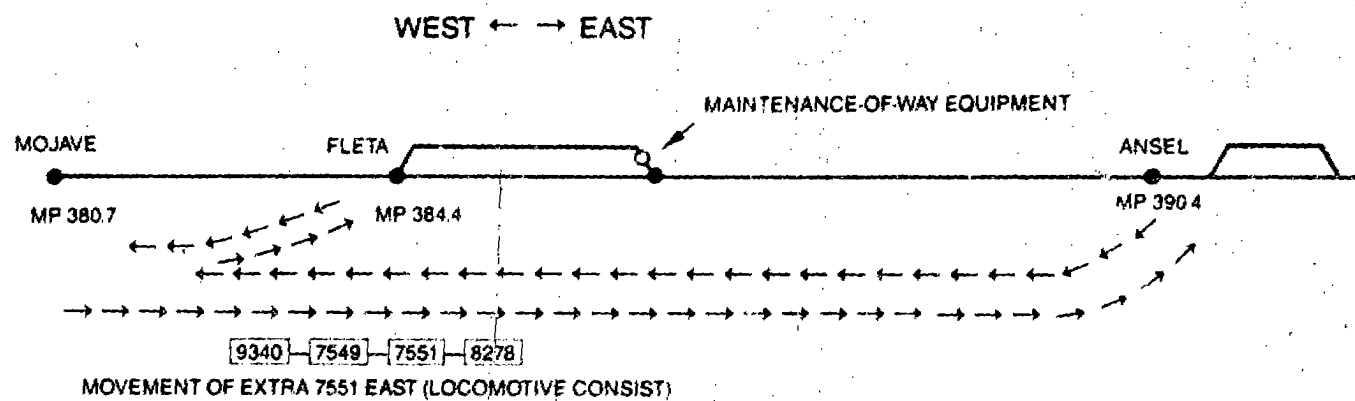
Figure 2.--Siding at Fleta.

\*UNIT SP 8278 WAS THE LEAD UNIT FOR THE MOVEMENT TO ANSEL  
 \*UNIT SP 9340 WAS THE LEAD UNIT FOR THE RETURN MOVEMENT TO FLETA

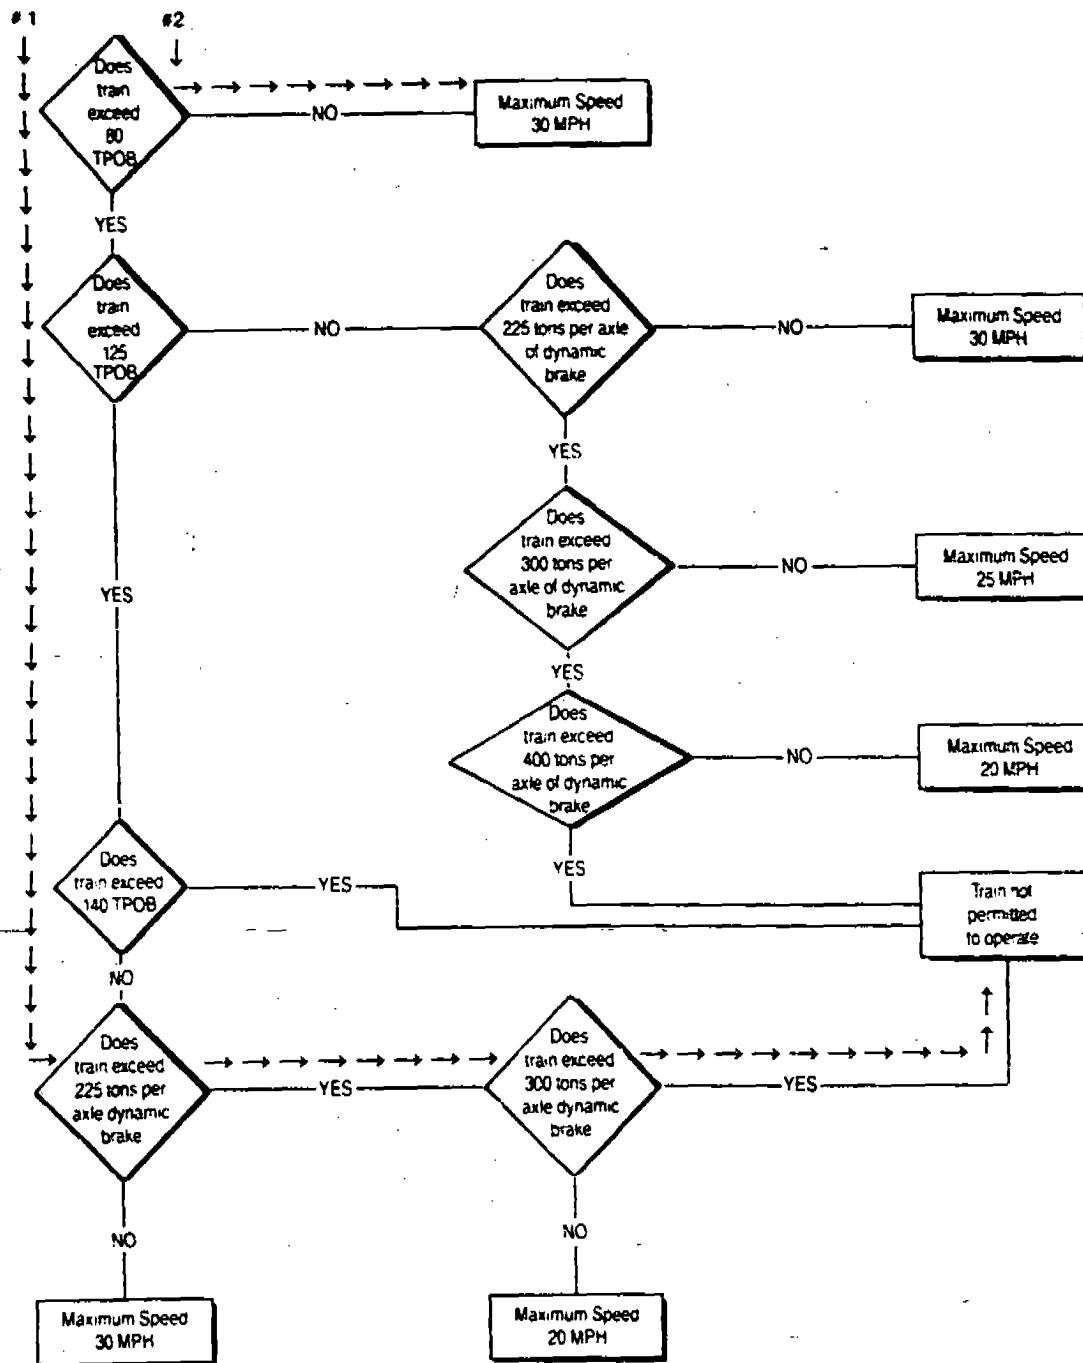
Figure 15.--Speed decision flow chart for Rule 33.

The SP's general road foreman of engines provided the Safety Board with a speed decision flow chart for Rule 33 (see figure 15). According to his testimony, "A train consisting of 69 cars with a weight of 8,900 tons and that had 18 operative dynamic brake axles" would not have been allowed to descend the grade east of Hiland. Extra 7551 East on the day of the accident had 128 tons per operative brake (8,900 trailing tons divided by 69 (number of cars in train, not using the 1 1/2 braking equivalence)) and 494 tons per axle of dynamic braking (8,900 trailing tons divided by 18 (three locomotive units with six axles each)). Using the speed decision flow chart, the general foreman illustrated why the train was not permitted to operate (follow arrow #1 on figure 15). Using the chart, the general foreman also illustrated the decision process the engineer would have made on the day of the derailment with the information that he had 69 tons per operative brake<sup>30</sup> (follow arrow #2 on figure 15). According to the general road foreman, "If the train would have had 6,151 tons, with the information that [the head-end

Extra 7551 East had an actual trailing tonnage of about 9,000 tons, 69 cars calculated with a braking equivalence of 1, and 18 axles (three locomotive units) of dynamic braking. Consequently, the train would have had 130 tons per operative brake (TPOB) and 500 tons per axle of dynamic brake. Based on Rule 33 of the company's operating rules, Extra 7551 East would not have been permitted to be operated down the 2.2-percent grade. (See figure 15, arrow 1.)

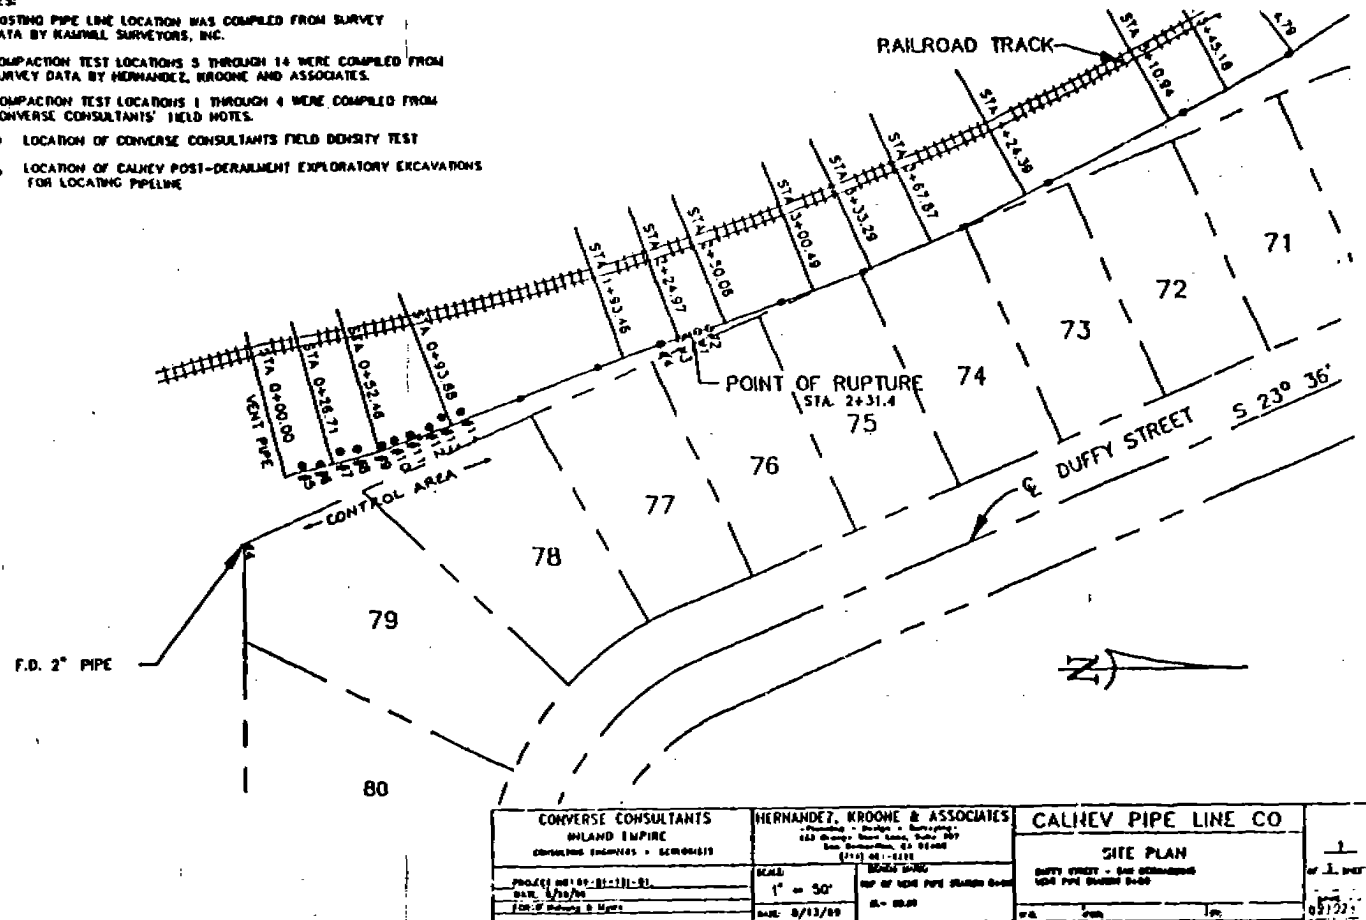
Figure 16.--Map from Converse Consultants' soil inspection report.

**Soil Inspection Report.**--On May 25, the day of the pipeline rupture, Calnev contracted with Converse Consultants, a geo-technical and environmental consulting organization, to perform work in the area of the pipeline rupture. As stated in its August 30, 1989, report of findings (appendix N), Converse Consultants' investigation "...was performed to evaluate the subsurface conditions in the vicinity of the pipeline rupture in order to locate areas where the soils may have been disturbed by excavating equipment. It is our understanding that excavating equipment may have been utilized in the vicinity of the pipe rupture during Calnev post derailment pipe inspection and/or during clean-up of the derailment debris." A total of 14 tests were conducted; tests 1 through 4 (figure 16) were performed within the area of the rupture, and tests 5 through 14 were conducted in an area ("control area") where Converse Consultants believed there had been no excavation or disturbance of the soil. According to Converse Consultants' report, tests of samples taken at locations 1 through 4 indicated "...disturbed or poorly compacted earth materials...and contained significant quantities of the mineral trona." Tests of samples taken at locations 5 through 14 indicated that the earth materials had not been recently disturbed. The tests indicated no presence of the mineral trona at these locations. A representative from Converse Consultants testified, "...my interpretation and conclusion is that the materials, backfill materials, which prior to the derailment would have been just clean, natural soils without the presence of trona, had become contaminated with trona by means of excavation and replacement, probably as backfill or certainly as materials that had been exposed to trona and mixed, by whatever means."

COMPACTION TEST LOCATIONS 1 THROUGH 4 WERE COMPILED FROM CONVERSE CONSULTANTS' FIELD NOTES.
